WESTWOOD NEIGHBORHOOD INFRASTRUCTURE REPORT

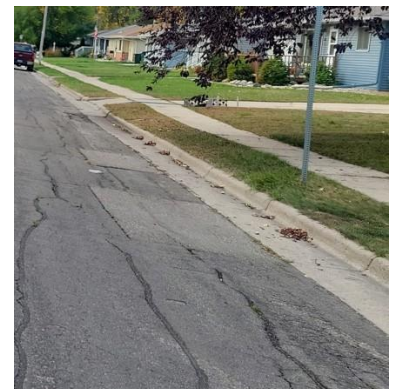
- No record of any significant street rehabilitation since the original installation in 1959.
- Signs of structural failure are observable in the neighborhood.

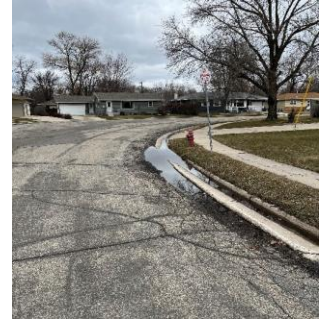
- The neighborhood's drainage was designed in 1957 to direct stormwater runoff to the southeast of the neighborhood. At this location the storm sewer collects it and discharges it into the river.
- Over time, settlement (gradual caving) along the street is causing improper water drainage. Because of this, there are ponding areas along the curbs.
- Road deterioration is increasing with the water ponding on the streets.

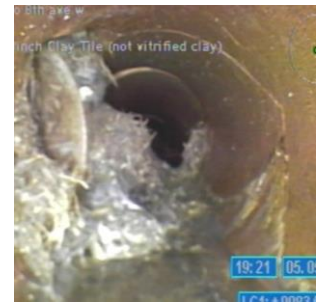
- The sanitary sewer consists of the original 8" Vitrified Clay Pipe (VCP).
- The useful life of VCP is approximately 60 years. As it ages it becomes brittle and is prone to structural failures.
- The current age of the neighborhood's VCP is approximately 60 years. Several areas of structural failures are on record.
- Pipes that collapse can result in sewer backup into residences

Structural failure observed on Oak Street

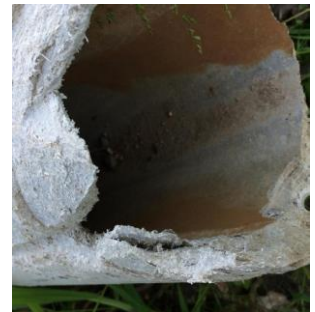
- The water main consists of the original 8" Asbestos Cement Pipe (ACP).
- The City of West Fargo has a standard of replacing all ACP pipe in reconstruction projects.
- The current age of the neighborhood's ACP is approximately 60 years. Studies show that the likelihood ACP breaks significantly increases after 50 years.
- Water main breaks cause disruptions in residential water service.

Example Asbestos Cement Pipe

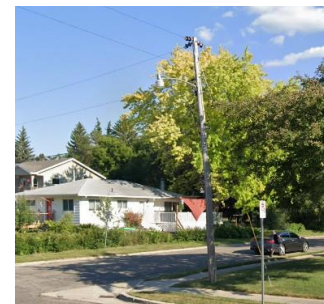
- Existing street lights are on wood poles. These wood poles are property of the utility company, not the City of West Fargo.
- Lighting is only at intersections, which is below current standards.
- Poor street lighting is a potential safety concern.
